ACTION C2: Implementation for demonstration of NWRMs on the catchment level coordinated by municipalities for climate adaptation on the hilly pilot

Milestones:- Report on the implementation of the NWRMs stream

IMPLEMENTATION REPORT

On the Mountainous and Hilly Water Retention Solutions Implemented in the Püspökszilágy

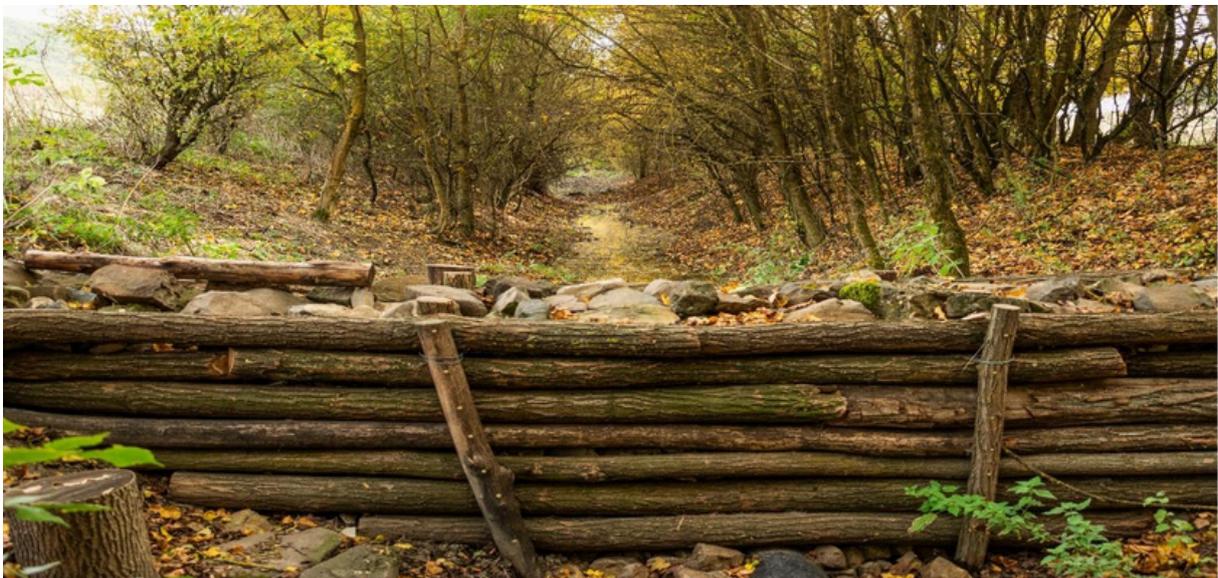
SEQ ábra * ARABIC 1. ábra Püspökszilágy Gombás-patak felső- és alsó gátja

Based on the design plans, two consecutive log check dams with energy-dissipating and sediment-retention functions were installed in the streambed using local materials (Figure 1). The locations of the structures were recorded with EOY coordinates: (1) EOY Y 665751.8; EOY X 270270.2, and (2) EOY Y 665838.4; EOY X 270249.9. The selected structure type is a double-row timber check dam, consisting of two single-row log barriers constructed approximately 0.5 m apart. The gap between the two rows was lined with geotextile and filled and compacted with CP 0–63 graded stone (or, depending on the design variant, local material) (Annex I: As-built design of Püspökszilágy Gombás Stream – “Muflon Garden”). The structural concept relies on sufficiently deep anchoring of vertical posts, lateral tying of horizontal elements into the stream banks, and protection against scour to ensure stability. Through backwater effects, the structures increase water residence time and improve local infiltration conditions.

According to the documentation, the main implementation steps included temporary water diversion, necessary earthworks, driving in the posts, fixing and anchoring the horizontal elements into the stream banks, placing the geotextile, and finally filling and compacting the interstitial space. A key principle was to minimize disturbance to the site through rapid and concentrated work execution, and to ensure that no construction waste remained in the area.

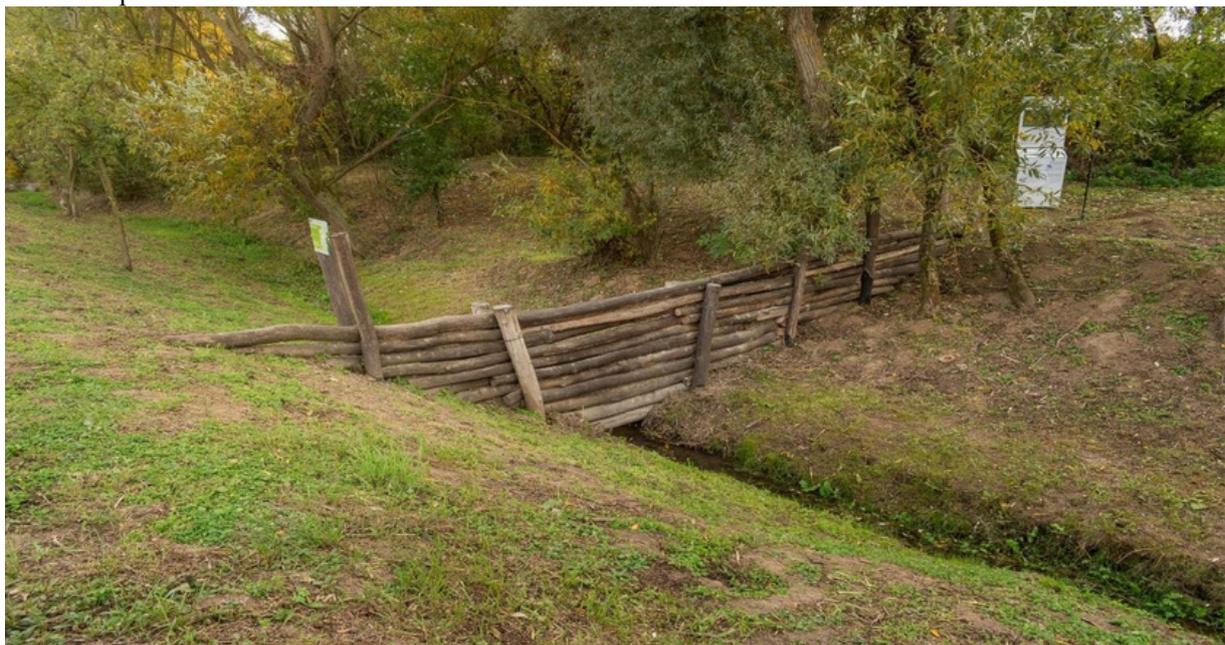
2. fgiure Püspökszilágy Malom logdam

The central element of the intervention is a large-scale log dam (Figure 2), which, during significant precipitation events—particularly flash floods—backs up the increased stream discharge. This reduces flow velocity and alleviates pressure on downstream sections. As a result of the backwater effect, part of the water is allowed to spread in a controlled manner onto the right-bank reed and meadow area. This both attenuates peak runoff and promotes infiltration, thereby supporting soil moisture retention.

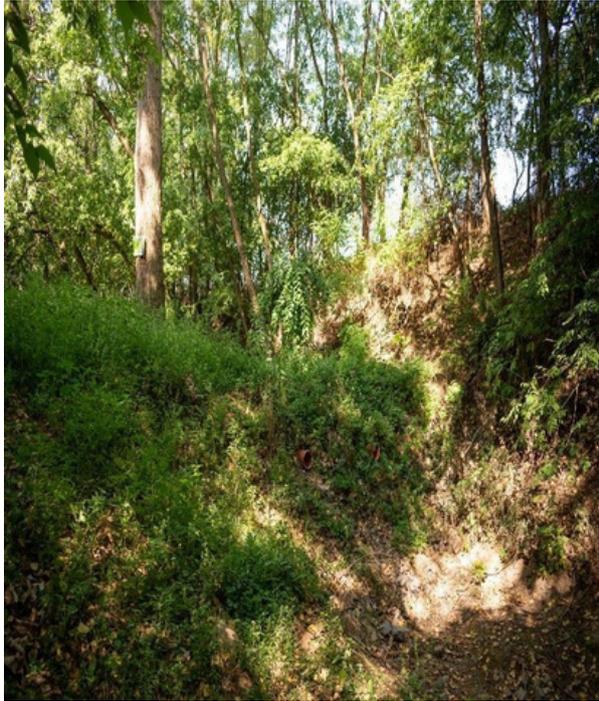
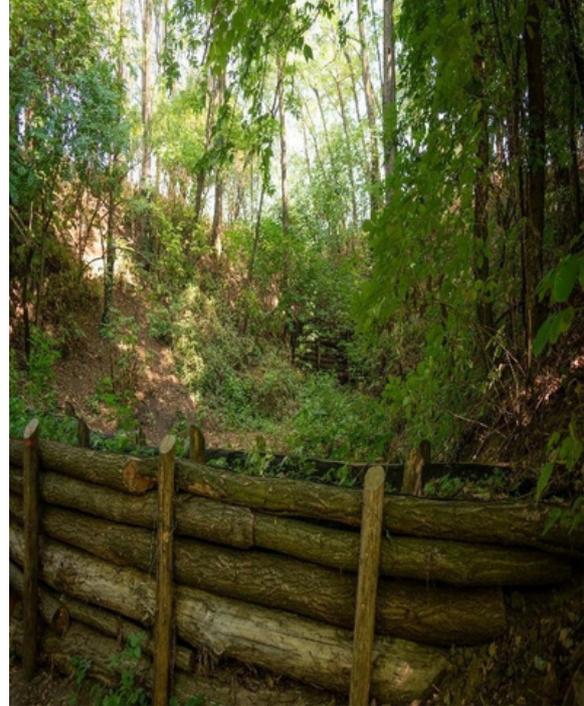
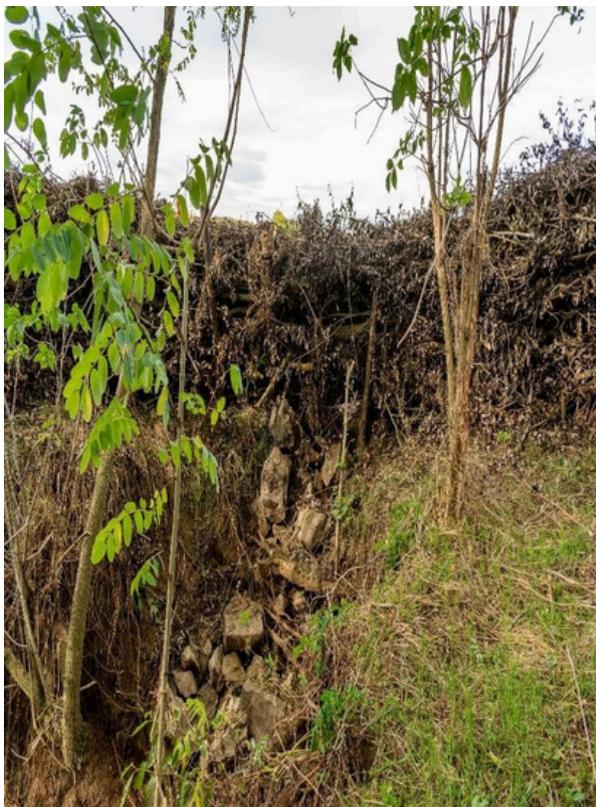
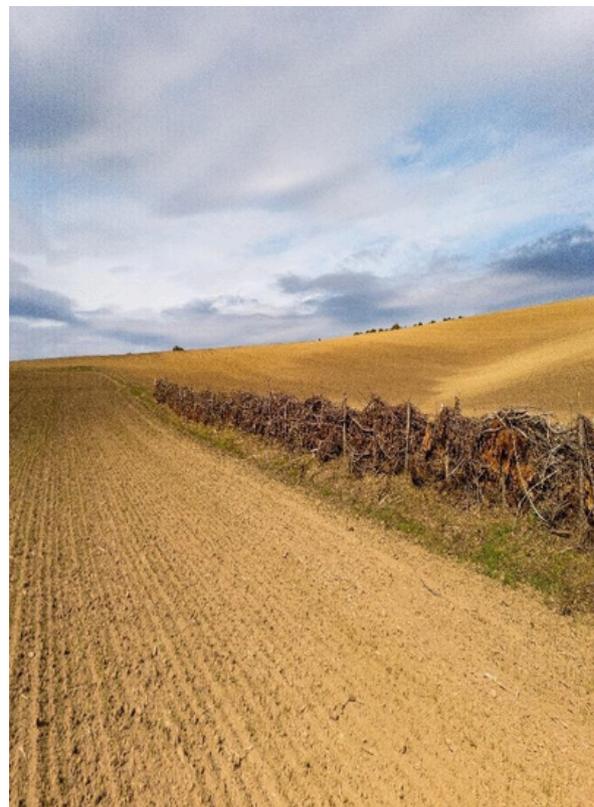
Implementation was based on establishing a multi-stage, mutually reinforcing system. On the lower, valley-bottom section, one water-retaining earth structure was constructed (Figure 3), designed to slow runoff, facilitate sediment deposition, and temporarily retain water. The planned storage area behind the structure has an approximate water surface of 340 m² and a net storage capacity of around 255 m³. The objective was not to maintain a permanent water body, but rather to allow retained water to infiltrate, thereby supporting soil moisture and stabilising the local water balance. During higher flow events, excess water can be safely conveyed downstream. Erosion protection at the earth structure is ensured by stone riprap reinforced with wire mesh.

Upstream of the earth structure, as a form of “pre-protection,” one double-row log dam was installed (Figure 4). Its function is to reduce flow energy and trap part of the sediment load before water reaches the earth structure, thereby protecting the storage area from rapid sedimentation. The double-row configuration—filled and stabilised between the two log rows in accordance with the design—creates a structure that further reduces flow velocity through backwater effects and promotes sediment deposition (Annex II: Püspökszilágy Kisköves as-built plan). The intervention affects parcels 015/3 and 015/4; the main structures are fixed by EOV coordinates (water-retaining earth structure: 669922.3 / 266956.2; log dam: 669953.3 / 266970.8).

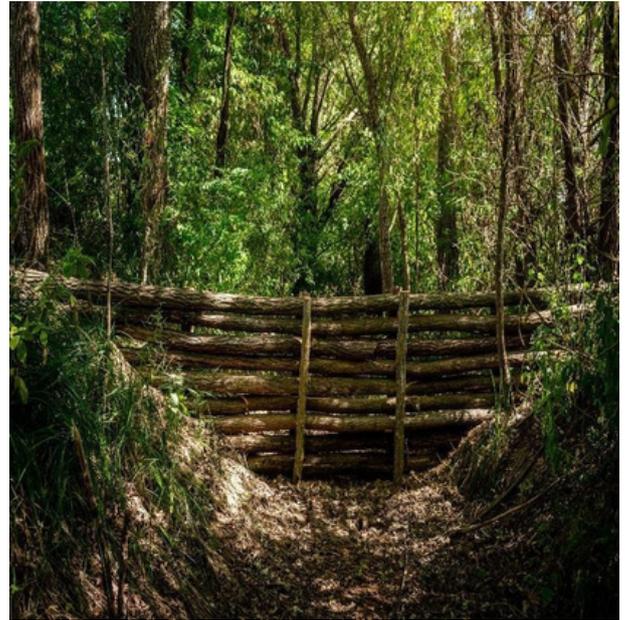
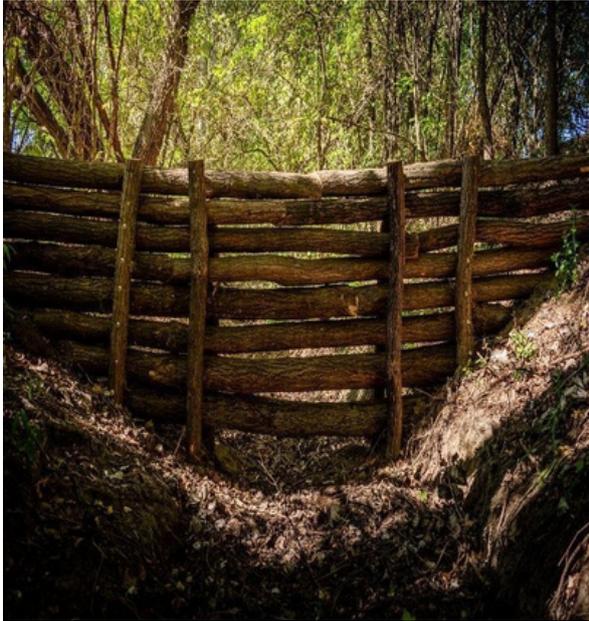
7. ábra Penc Szirota helyszínén kihelyezett rönkgátak

At the intervention site designated in the Szirota area of Penc (parcel no. Penc 04), located outside the settlement boundary, two consecutive single-row wooden log dams designed to slow runoff and trap sediment were planned and implemented within the framework of the LIFE LOGOS 4 WATERS project (Figure 7). The site is a temporary drainage ditch and does not involve a permanent watercourse. The objective of the intervention was to reduce the energy of sudden surface runoff generated during heavy rainfall events, create short-term in-channel storage, retain sediment locally, and thereby reduce pressure on sections closer to the settlement.

From a technical perspective, each single-row log dam consists of 2–4 vertical posts and horizontally placed logs arranged with gaps. The vertical elements have a minimum diameter of 20 cm and are embedded at least 80 cm into the ground. The horizontal logs are fixed using screws and carpentry staples. During construction, particular importance is given to anchoring the horizontal elements into the channel banks (minimum 50 cm) and ensuring proper wedging and stabilisation against scour. The design ensures overtopping of water above the dam crest, allowing low flows to pass while temporarily backing up higher flows to promote sediment deposition (Annex III: Penc Szirota as-built plan). The implementation followed the approved construction drawings.

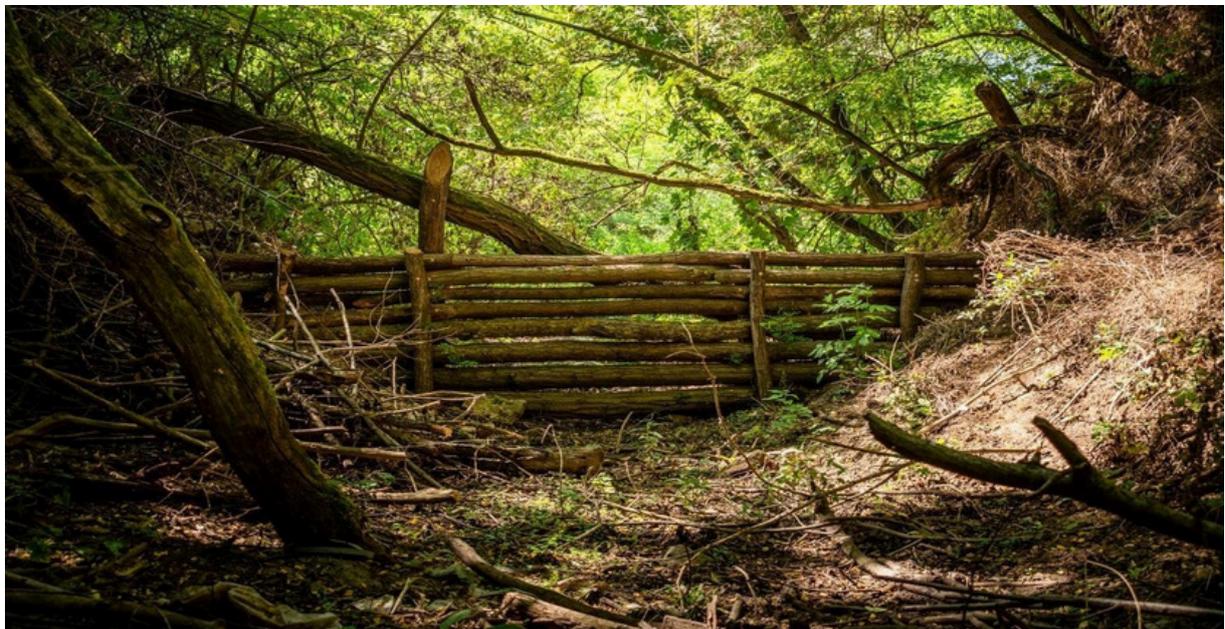
8. figure Penc Téglaházi major I. logdam

The upper structure is a single-row wooden log dam primarily serving as an energy dissipator, backwater structure, and sediment trap. Its crest height is up to approximately 1.5 m. Under low-flow conditions, water can pass through; during higher flows, the backwater effect promotes sediment deposition. The lower structure is a double-row log dam filled with local material (stone and cohesive soil) and protected by geotextile. The gap between the two rows (approximately 0.5–0.8 m) is filled with compacted material. Its primary function is to enhance longer water retention and strengthen local water storage capacity (Annex IV: Penc Téglaházi major as-built plan).

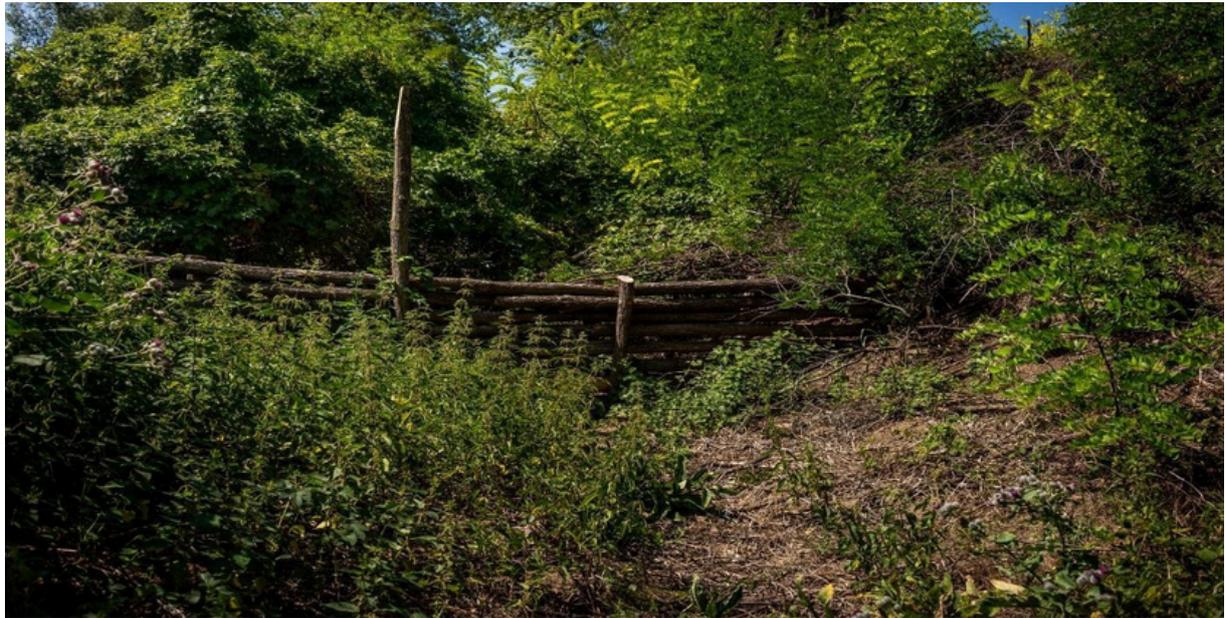
9. figure Penc Téglaházi major II. logdam

In the outskirts of Penc, along the Penc branch (parcel no. 061/2), on the section behind the Téglaházi major, a small-scale, nature-based water retention and sediment trapping intervention was designed within the framework of the LIFE LOGOS 4 WATERS project. The objective was to slow down sudden runoff during heavy rainfall events, increase the residence time of water within the channel, promote infiltration, and reduce peak flood flows and sediment loads reaching the built-up area. At the site, there is an approximately 10 m deep and 10–25 m wide gully with steep, eroding banks of limited stability. The technical solution consists of the construction of two log dams (Figures 8–9) with complementary, sequential functions (see Annex I: site plan; Annexes II–IV: log dam details and longitudinal profile).

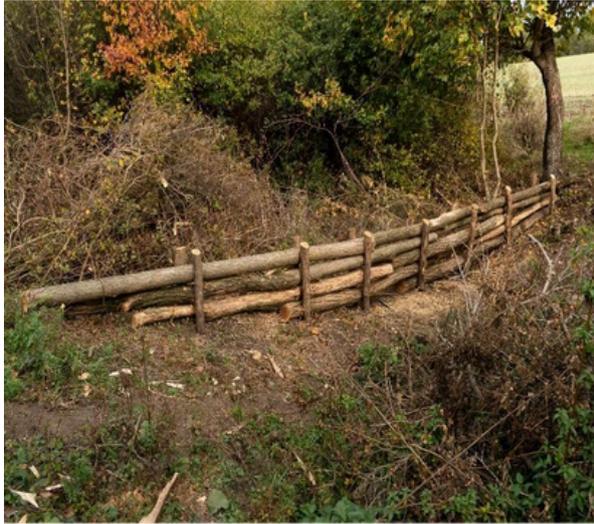
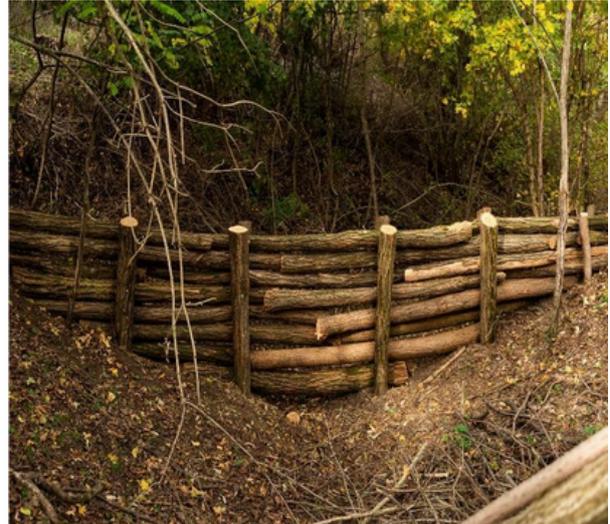
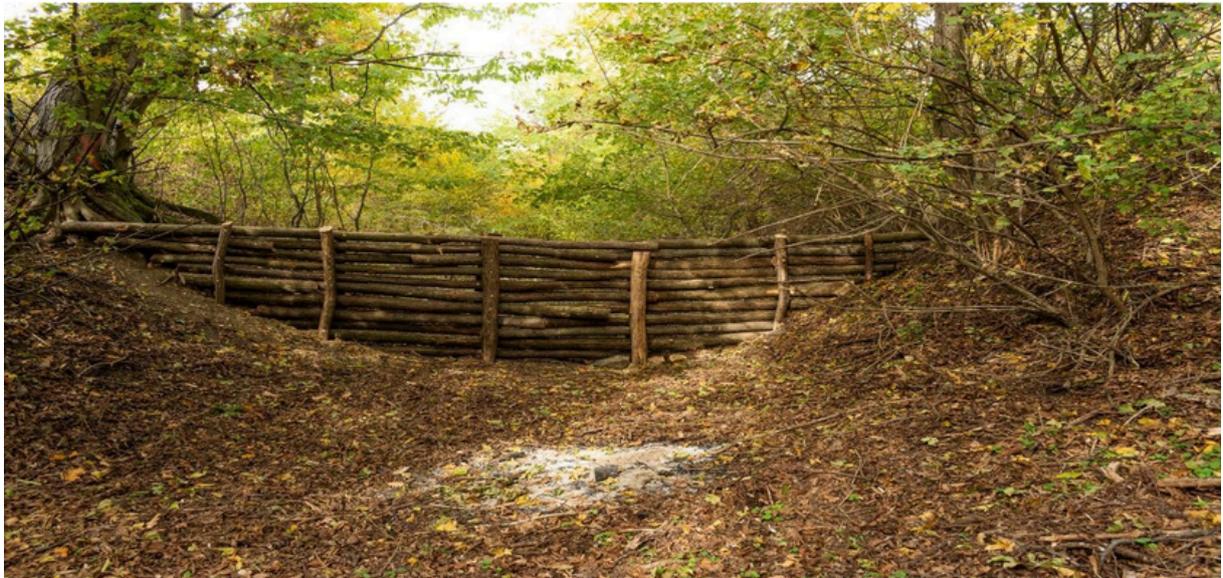
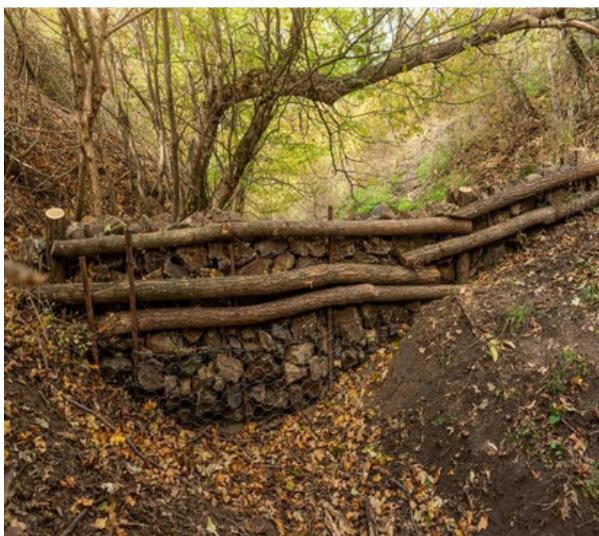
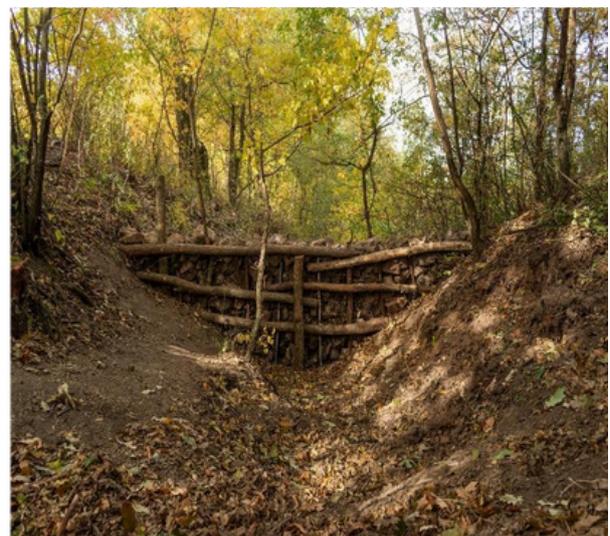
10. ábra Püspökatvan Takács-hegy rönkgátai

During implementation, five small-scale, locally sourced sediment-trapping and flow-slowing structures were constructed in a cascaded arrangement (Figure 10). Their cumulative effect reduces the hydraulic and sediment load reaching the built-up area.

- Single-row timber log dam – EOV Y: 675408.5; EOV X: 269512.2
- Driven single-row timber stake barrier – EOV Y: 675369.8; EOV X: 269560.6
- Double-row log dam with 0–63 mm stone infill and geotextile protection – EOV Y: 675310.5; EOV X: 269619.9
- Double-row log dam with local inert material infill – EOV Y: 675230.8; EOV X: 269668.2

- Double-row water-retaining log dam made of local material (earthfill-type water retention structure) – EOY Y: 674982.1; EOY X: 269495.6 (Annex V – Püspökhatvan As-Built Plan)

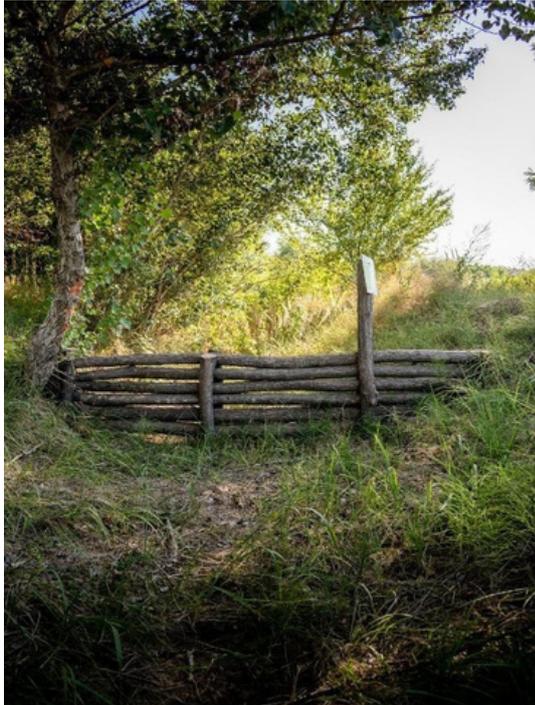
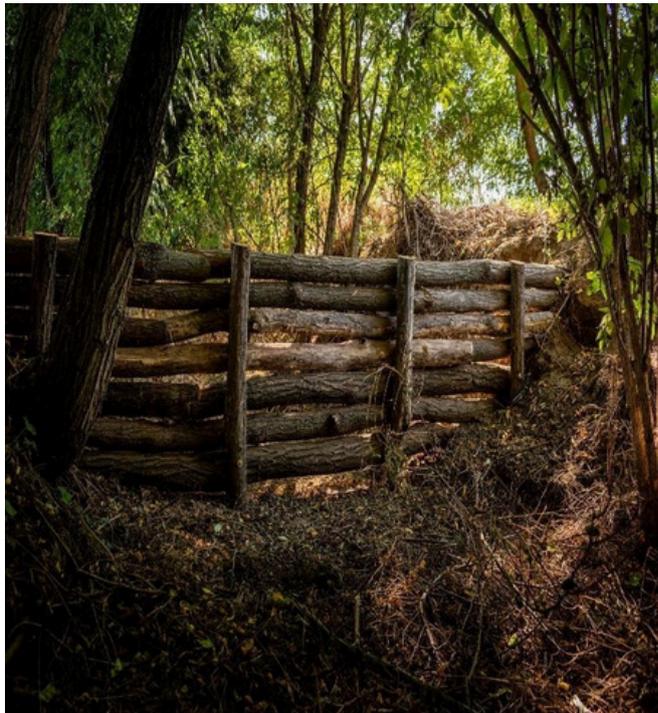
11. ábra Vácduka-árok elkészült rönkgátai

As technical content of the intervention The works included the construction of 2 single-row timber log dams (Figure 11), and a minor dredging of the downstream section of the ditch. The purpose of the log dams is to break the flow energy within the channel, create backwater effects, and promote sediment deposition, while allowing low flows to pass and enabling larger flows to overtop the structure in a controlled manner. The locations of the structures are recorded with EOVS coordinates:

According to the design drawings, the single-row log dams consist of 2–4 vertical posts and horizontally placed logs installed with gaps between them. The vertical elements have a minimum diameter of 20 cm and are embedded to a minimum depth of 80 cm. The horizontal logs are fixed using screws and carpenter's staples. Key technical requirements include anchoring the horizontal elements into the channel banks (minimum 50 cm), and stabilizing against scour and overturning using wedged stone material reinforced with wire mesh. A minimum overtopping height of 30 cm must be ensured above the structure so that larger flood flows can still pass safely (see Annex VI: As-built plan of the Vácduka Ditch site).

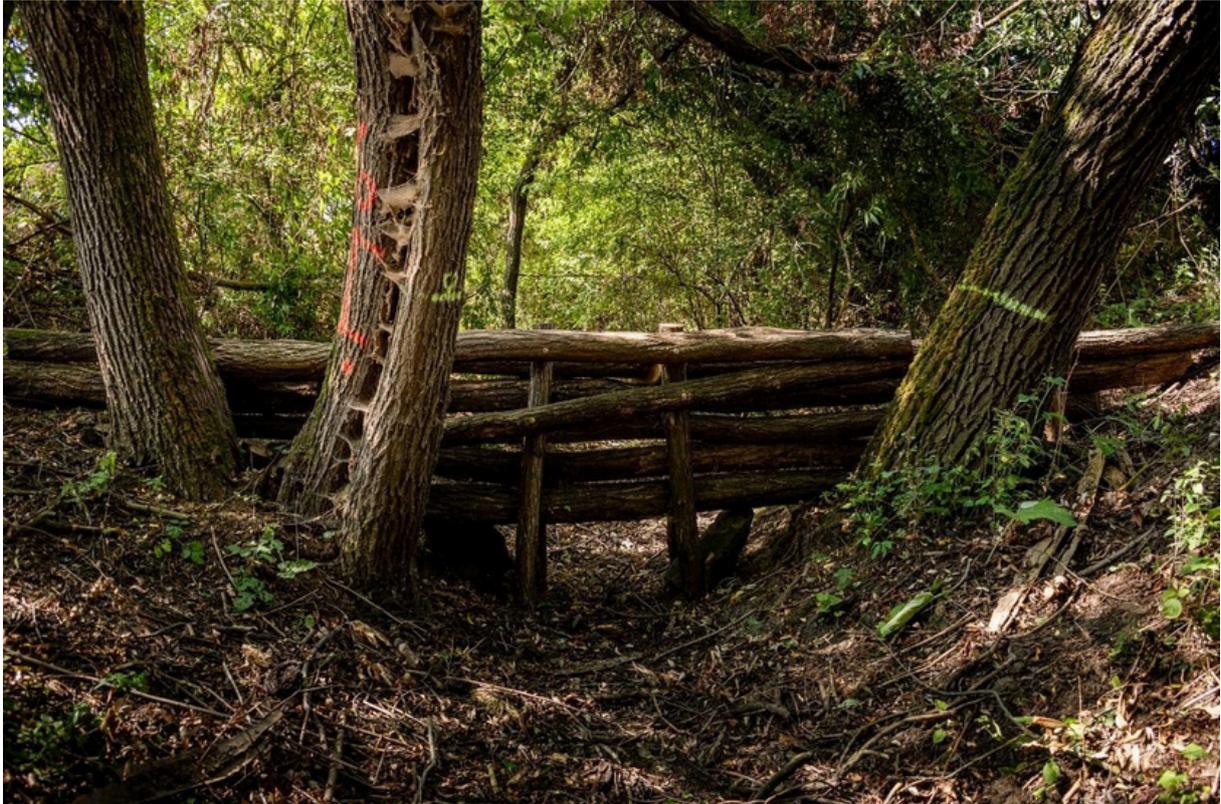
12. figure Kosd/Rád Rádi-stream logdam

According to the technical design, the log dam consists of 2–4 vertical posts (minimum 20 cm diameter), driven at least 80 cm into the ground. Horizontal logs (minimum 15 cm diameter) are placed with gaps between them, up to a maximum height of 0.8 m. The horizontal elements must be anchored into the channel banks to a minimum depth of 50 cm. Stability against scour and overturning is ensured by wedged stone material stabilized with wire mesh. A minimum overtopping height of 30 cm must be maintained to allow safe conveyance of larger flood flows. (See Annex VII: As-built plan – Kosd/Rád site.)

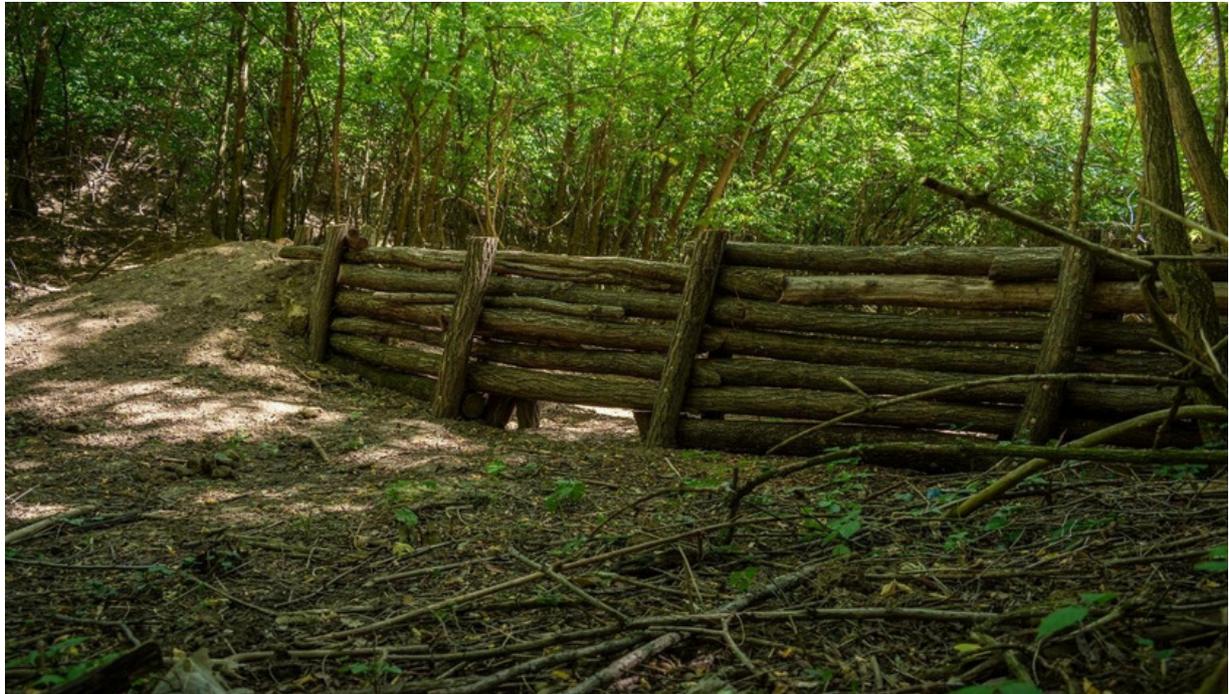
13. figure Väckisújfalu Új telep I. logdam

At the site, runoff from the southern catchment area—particularly from large contiguous arable fields—concentrates in forested gullies during intense rainfall events. This process both accelerates gully erosion and leads to sediment accumulation and overloading of the paved roadside stormwater drainage ditch along Újtelep, regularly causing local flooding and operational challenges. The sub-catchment area is approximately 7.2 hectares. To mitigate these impacts, the planned solution involved the installation of two energy-dissipating, flow-slowing single-row timber log dams at the confluence of the two channels, within forest land (Figures 13–14).

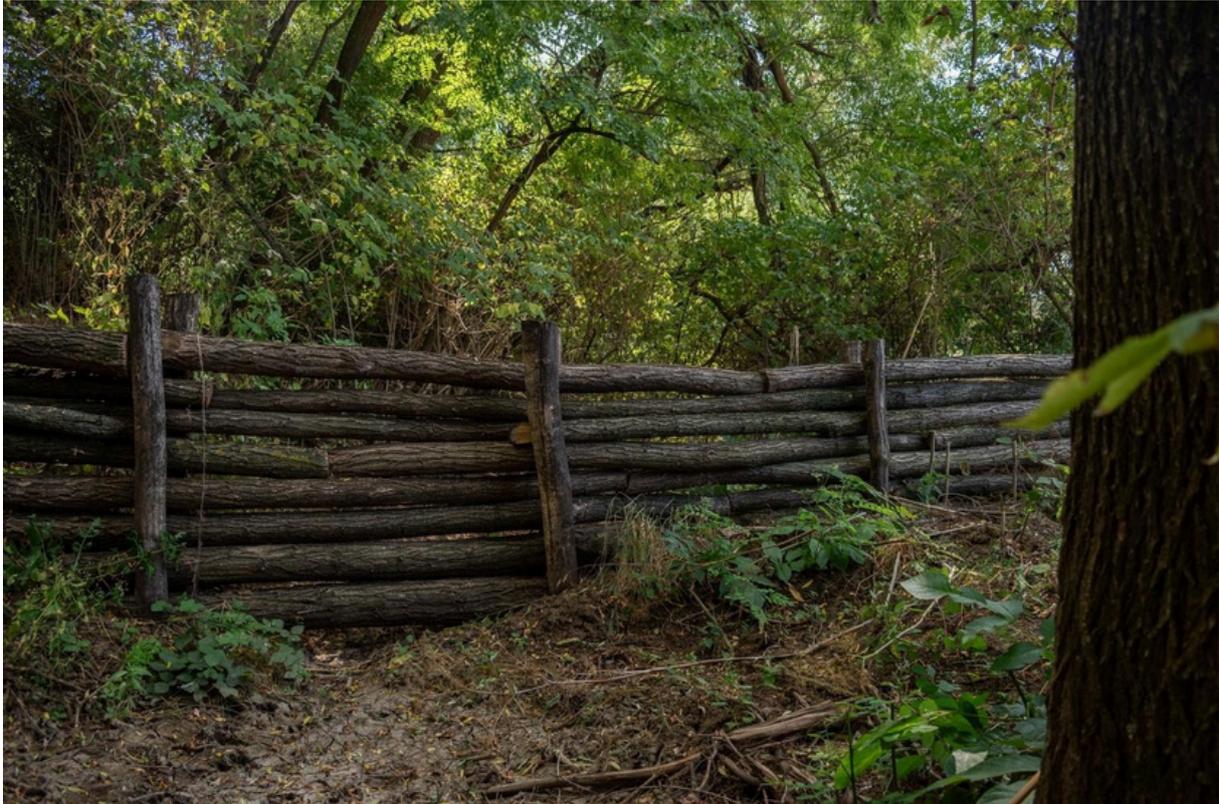
15. figure Kisnémedi Némedi-patak single-row logdam

According to the design documentation, the log dam consists of: 2–4 vertical timber posts, each with a minimum diameter of approximately 20 cm and horizontally placed logs, installed loosely up to a maximum height of approximately 0.8 m. The vertical posts are driven to a minimum depth of approximately 80 cm. The horizontal logs are fixed using screws and carpenter’s staples. Key structural requirements include anchoring the horizontal elements into the stream banks (minimum ~50 cm), stabilisation against scour and overturning using wedged stone material reinforced with wire mesh (as detailed in Annex X – Kisnémedi as-built design documentation).

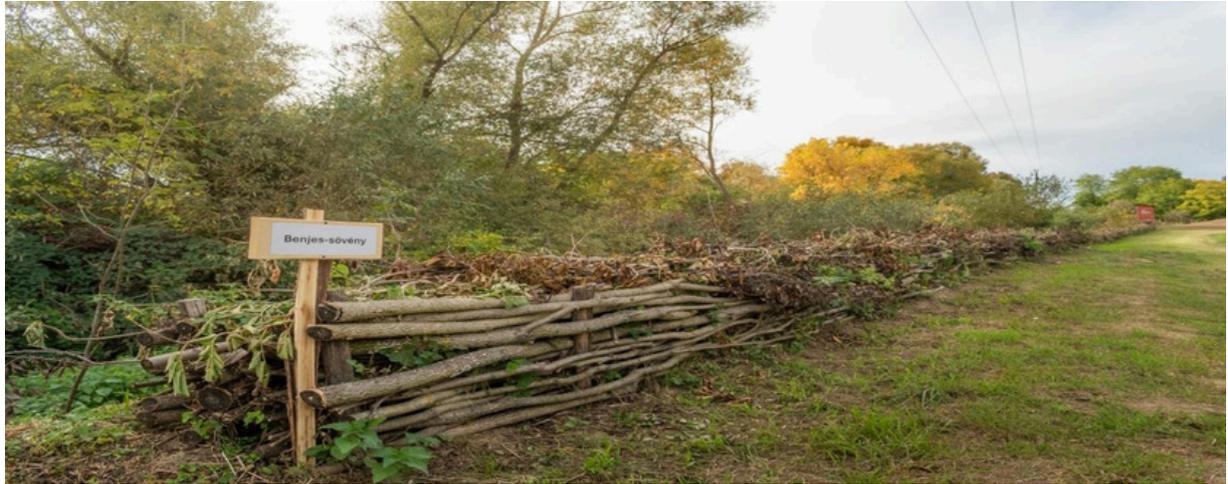
16. ábra Püspökszilágy Malom Benjes hedge

A Benjes hedge (a linear barrier constructed from brushwood and pruned branches) slows down sediment-laden runoff arriving from the slope, filters suspended material, promotes local sediment deposition, reduces the destructive energy of flowing water, and enhances soil moisture retention and infiltration. As a result, the hydrological balance of the valley bottom becomes more stable, and with the gradual re-establishment of vegetation, the microclimate of the area shifts in a favourable direction.

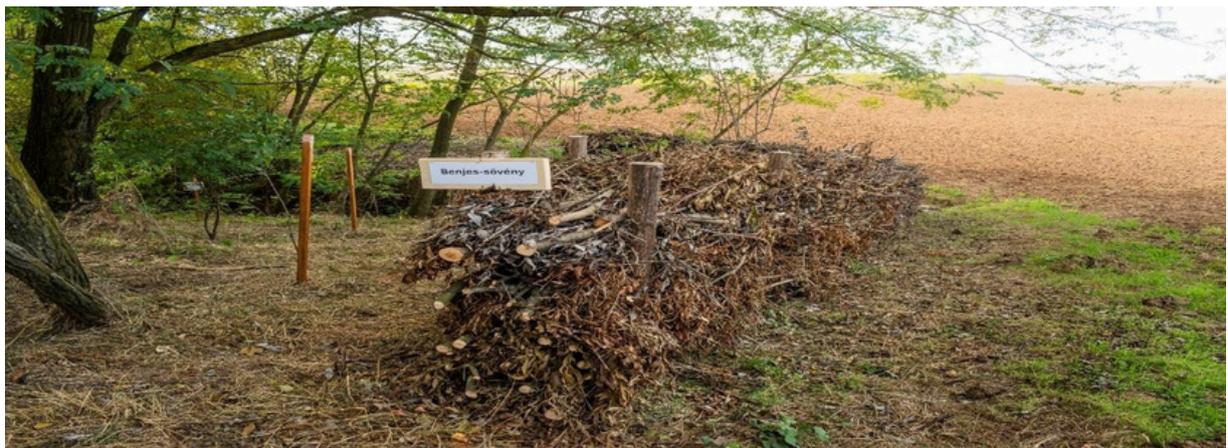
17. ábra Püspökszilágy Kisköves Benjes hedge

Together, this system halts channel degradation, retains sediment locally, and slows runoff in a cascading, mutually reinforcing manner. This combined solution completes the protection of the Kiskövesi branch of the Szilágyi Stream, contributes to improving groundwater conditions, increases infiltration, and supports the maintenance of the newly emerging, more favourable microclimatic conditions.

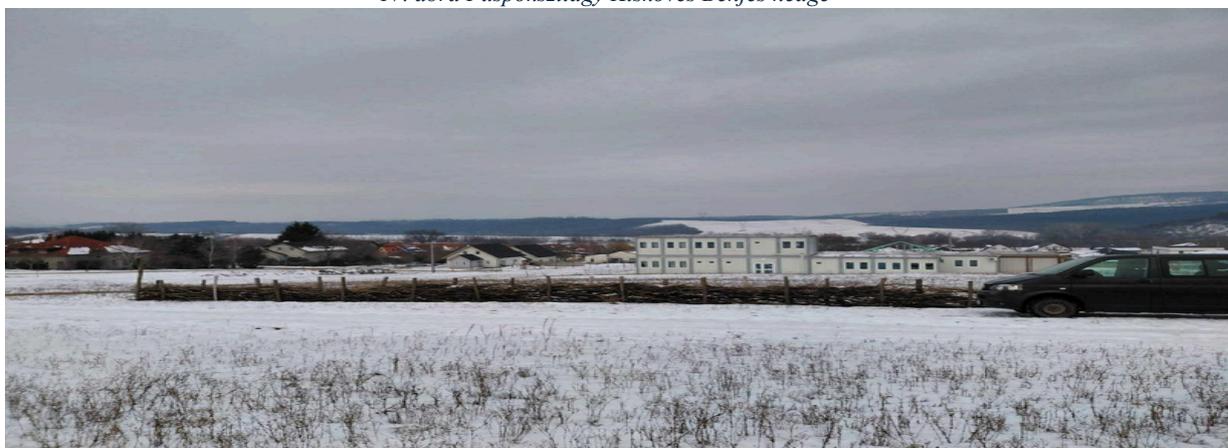
18. ábra Vácduka-iskola Benjes hedge

This solution already reduces runoff peaks and prevents sediment from entering the built-up area.
